**UNITED STATES ENVIRONMENTAL PROTECTION AGENCY
REGION 10
1200 6TH AVENUE
SEATTLE, WASHINGTON 98101**

SUBJECT: CLEAN AIR ACT INSPECTION REPORT
Republic Services Roosevelt Regional Landfill, Roosevelt, WA

Date of Inspection: On Site Inspection: June 28, 2022
Virtual Conference: July 7, 2022

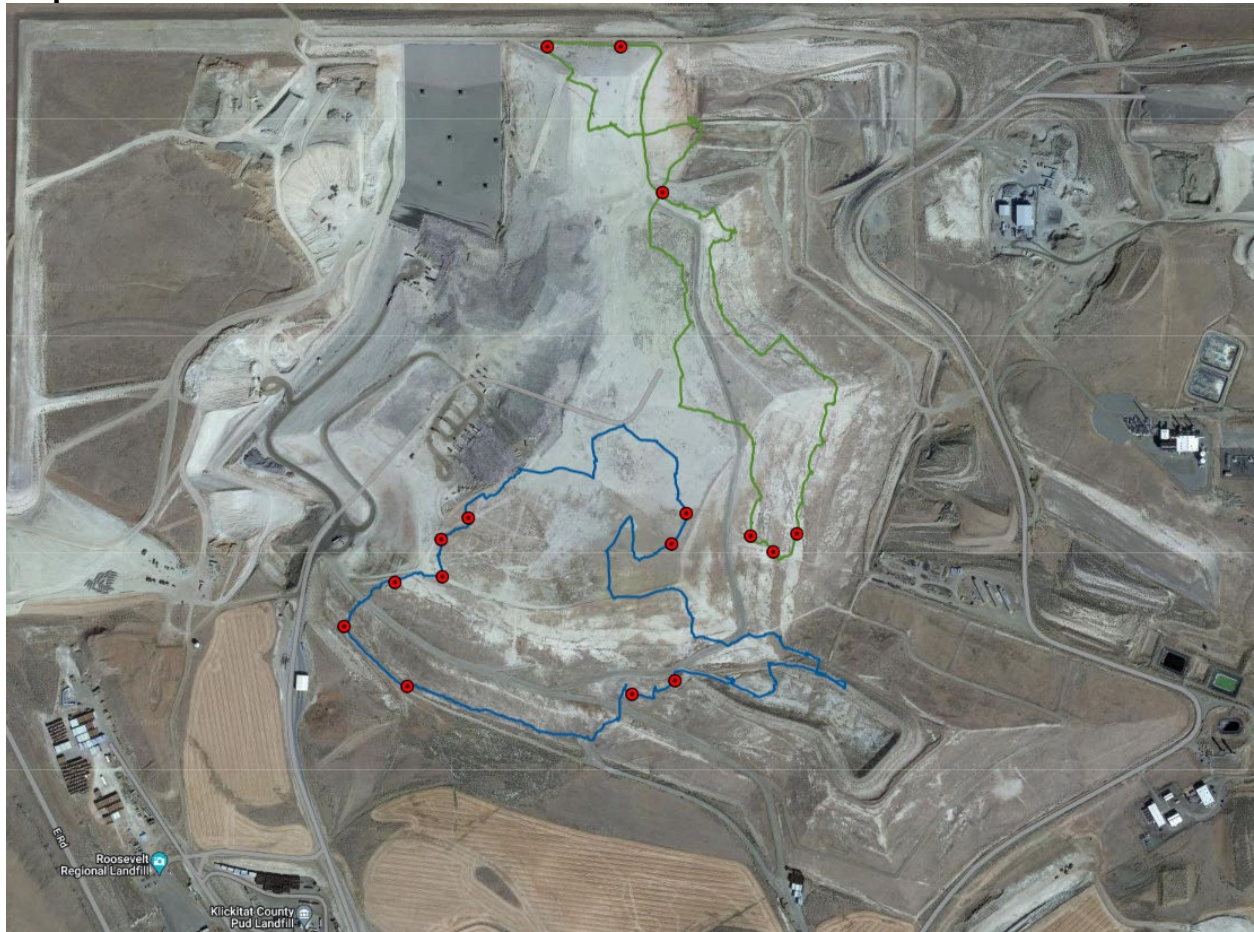
Map of Detected Exceedances

Daniel Heins expressed as a concern that despite Republic having never found any SEM exceedances in its past 5 years of quarterly monitoring, including a full year of checking all penetration points, EPA identified 16 points in exceedance of 500 ppm, including 5 points above 10,000 ppm, indicating potential concerns with Republic's SEM/Method 21 procedures.

Flag #	Reading (ppm/%)	Description	Latitude	Longitude
1	2400	T18A1, where horizontal exits dirt	45.81478218	-120.1825788
2	5%	T18-A4, where horizontals exit dirt (two animals burrows)	45.81478541	-120.1807079
3	1200	17VO3, base of well	45.81219925	-120.1796552
4	730	10V06	45.80618911	-120.1762359
5	2200	A10TPO3, valve for header	45.80587112	-120.1768405
6	2%	Abandoned well(?) uphill from 10R16 (small open pipe and base of larger pipe)	45.80615	-120.177414
7	3400	LC058, where exits dirt, also un-gasketed cap	45.80456151	-120.1877082
8	1000	08V02 (base)	45.80532307	-120.1864192
9	1%	Pipe in ground by 8V08	45.8054303	-120.185231
10	1500	08V11 at base	45.80608553	-120.1852499
11	600	Remote wellhead(?) ~50' west of 9B01	45.80647645	-120.1845794
12	1200	10V19 at base	45.80654769	-120.1790285
13	1%	6V11 at base	45.80601013	-120.1794204
14	6000	Wood covered valve box	45.80357938	-120.1793451
15	1.5%	Exposed hose coming out of dirt	45.80335383	-120.1804316

16	1000	LC057 at meeting with dirt	45.80349002	-120.1861183

SEM exceedance locations plotted over Google Maps satellite imagery. Approximate monitoring paths included, derived from GPS data. Morning path shown in green, afternoon in blue.
